NAVAL POSTGRADUATE SCHOOL

THESIS

EXPERIMENTAL STUDY OF COMPOSITES AND METAL-WIRE JOINTS

September 2008

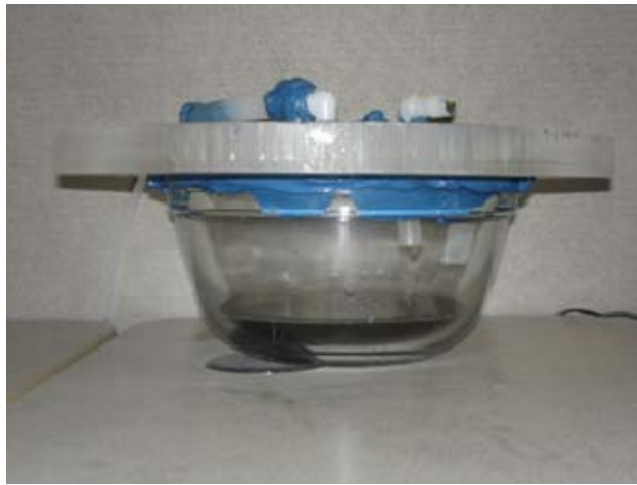
Figure 5. Resin Trap

The resin trap, Figure 5, prevents the excess resin from contaminating the gauge board or the vacuum pump. It is made from a glass bowl sealed by a lid with inlet and outlet tubing allowing the resin to fall in to the bowl while allowing the air to pass through to the vacuum pump.
